LIFE04 ENV/FI/000299

Report on the prototype constructions of the EquineLife project

MTT Agrifood Research Finland

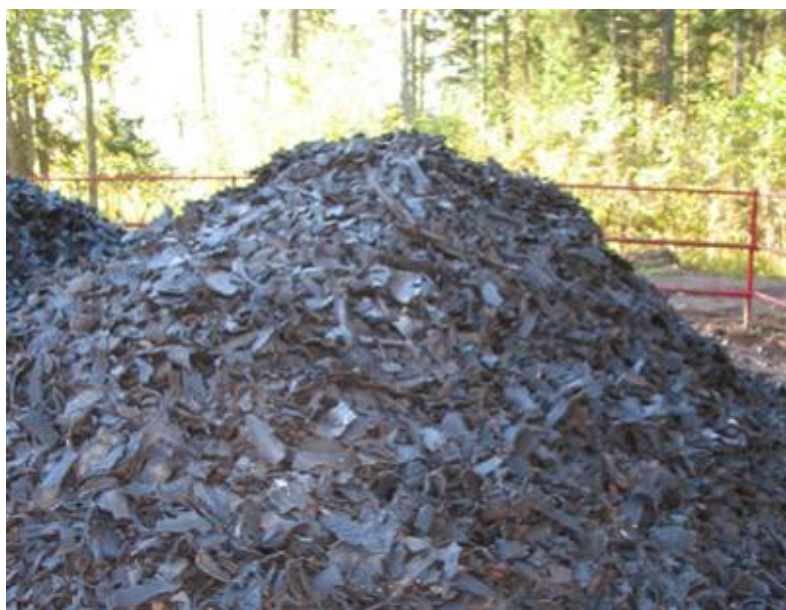
Fig 1. Chopped car tyres used for constructing the elastic paddock surface.

Chopped tyres (see fig. 1.) were applied as a 30 to 40 cm layer on the surface of a paddock in a southern slope 15,8 x 44,8 m in size, which has been in paddock use for twenty years. During these years the paddock surface has been replaced three times and at the same time also refenced. Eight years had passed since the last time. The paddock has no subsurface drainage. The work at this test paddock site was carried out in October 2005 and it could be taken into use at the end of October 2005. The upper layer of the paddock was removed exposing the layer with stones and crushed stones. On this a 300 mm layer of chopped car tyres was applied. This layer was covered by a textile fiber cloth. On this a 200 mm layer of 0 – 16 mm crushed stone was spread. For the first face of the work (removing the old layer and applying the chopped car tyres) it was needed two days of work, another two days was needed to apply the textile fibre cloth and the crushed stone layer and one day was used for restoring the fences. In this paddock horses have been kept very intensively as already the first one to three horses are taken out into the paddock at six o'clock in the morning for one and a half hour. The next turnout (one to three horses) is between 8 to 12 a. m. and the last turnouts (one to three horses) are from 1 to 8 p. m. Often the adult students bring their horses to this paddock even later. The faeces have been collected from the paddock

This paddock has been used has been dry all through the winter and spring 2007. During the winter this paddock did not become frozen and hard as other paddocks. It remained soft and elastic also during the time snow was melting and during rainfall periods. Pieces of chopped car tyres have still come up from paddock base and these pieces need to be taken away as these pieces contain steel wires, which can be harmful to horses.

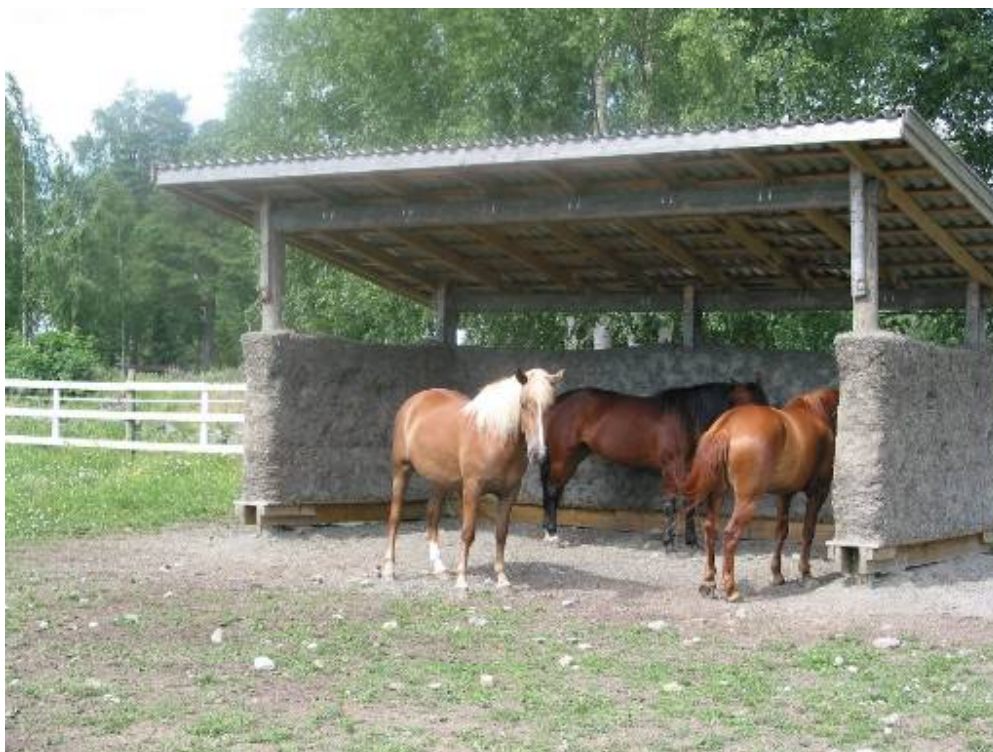
Fig. 2. The clay-straw weather shed built at the Equine College Ltd, Ypäjä in summer 2007 (photo Helena Jansson).

A clay-straw weather shed was constructed at the Equine College Ltd, Ypäjä in autumn 2005. As bearing construction was round wood. This is a low cost material and can also be found as recycled. As the bearing construction a round pillar construction was chosen as it is a low cost material. The pillars were placed three meters from each other. As roof construction a pitched roof was chosen.

The pillars were placed in holes to a depth where the frost will not affect them. The upper reaches were applied and fastened after an equalization cut of the upper tops of the pillars. Under the tin roof reaches planks (50 mm x 125 mm) and boards (32 mm x 100 mm) were used (Fig 1). It was obvious that to make the building insensitive to wind the clay-straw would not be enough. Thus crosswise steel bars were applied within the clay walls.

The base construction was made of pressure treated 50 x 200 wood plank and 32 x 100 board (Fig. 2).

The plywood forms for the wall construction were filled with a mixture of 10 % (weight) straw, 20 % water and 70 % clay. The walls are 40 cm wide. This construction work took 108 hours. The horses have eaten some holes into the walls.

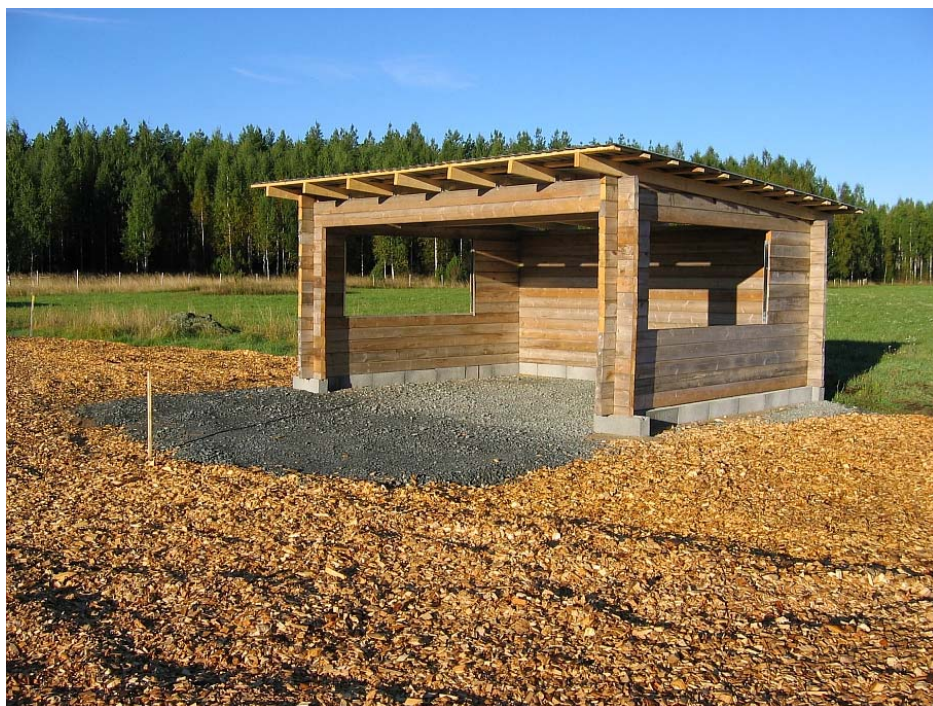
Fig. 3. Weather shed built at Kuuma. In the foreground the paddock area with wood chips can be seen. Note the crushed stone powder area in the front of the shelter (photo Aaro Närvänen).

The digging work was carried out by Jouko Norri ltd. Jari Kauha assisted in the paddock work and built the two (5 x 4 m) weather sheds and established the fences. For construction of the weather sheds recycled wood was used. These weather sheds are divided into two parts 10 m² each and are used by horses from two paddocks (fig 3). Aaro Närvänen and Jari Kauha were the work leaders in the paddock renewing work.

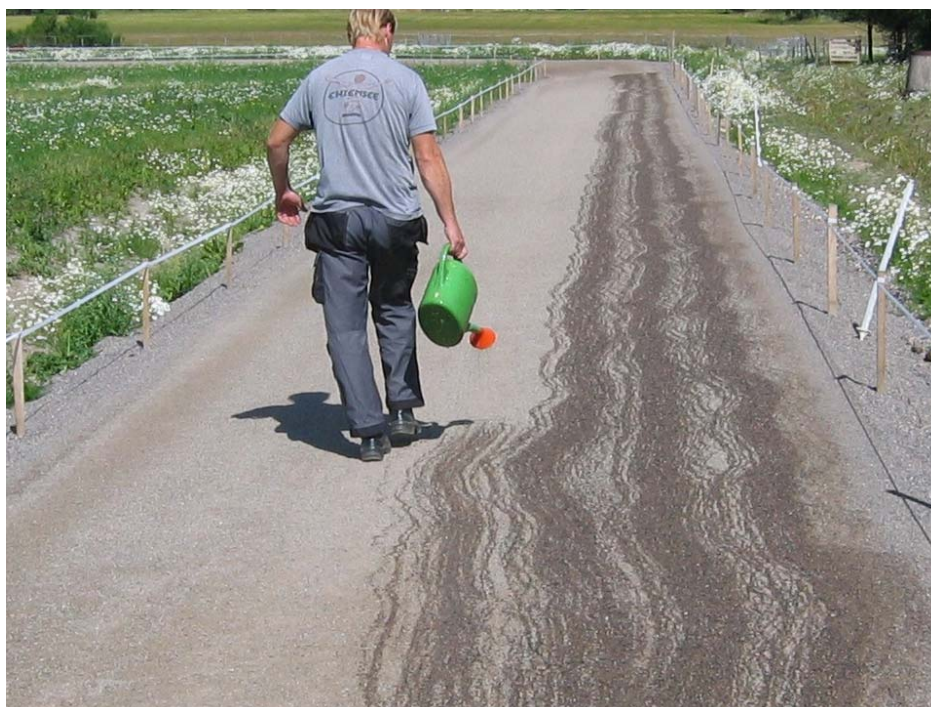
Fig 4. Spreading ferric sulphate solution on the Kuuma oval track (photo Aaro Närvänen).

At Kuuma we tested two chemicals for lowering of the phosphorus load from the oval track build. In fig. 4. the water suspension of ferric sulphate is spread to the straight part of the oval course, which is closer to the buildings (<http://www.kuumanhevuset.fi/>). In addition ferrous sulphate suspension is spread to the surface of the other straight part of the course. For comparison the curves are not treated. The applied amount of ferrous sulphate was 40 kg as well as the amount of ferric sulphate.

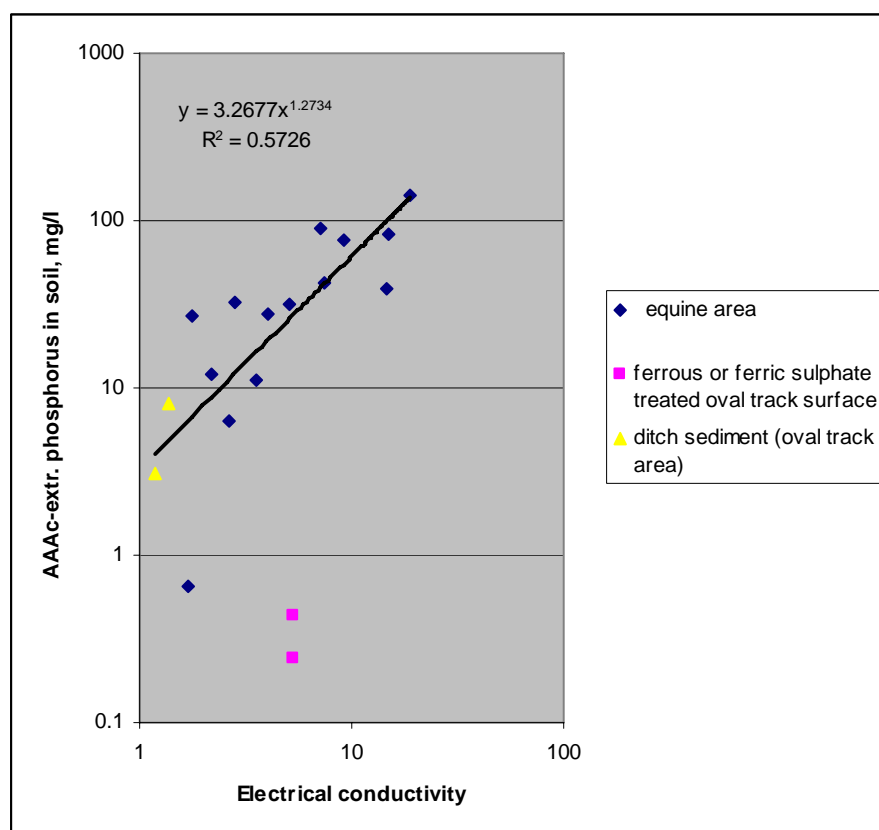
Fig. 6. Regression of electrical conductivity (10^{-4} S/cm) on AAAC-extractable phosphorus in different equine areas. The ferrous or ferric treated soils and the ditch sediment samples are not included in the equation.

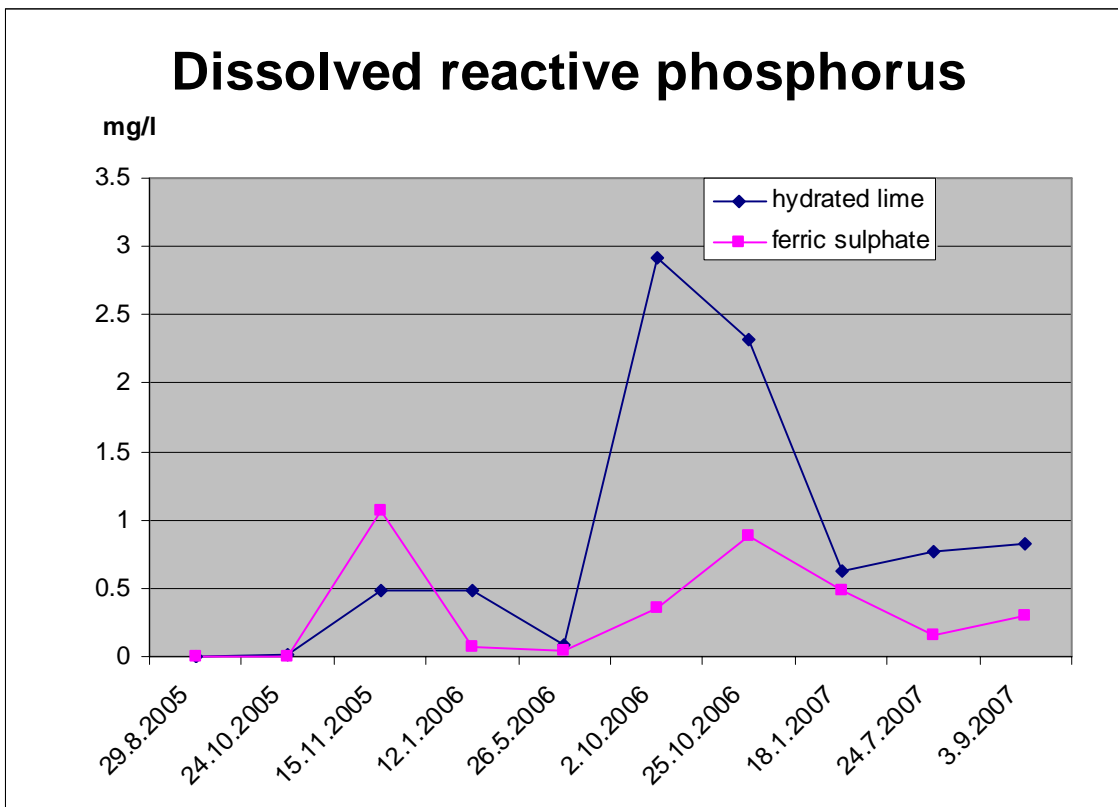
Fig 7. Contents of dissolved reactive phosphorus in runoff water from the Kuuma paddocks treated with hydrated lime or ferric sulphate.

The soluble iron content was lower in the water from the ferric sulphate treated paddock area compared to the hydrated lime treated area. This was not expected but a lowering in the content of soluble iron in the water from ferric sulphate treated field ditch water compared to untreated water has also been observed (Närvänen and Jansson, 2007).

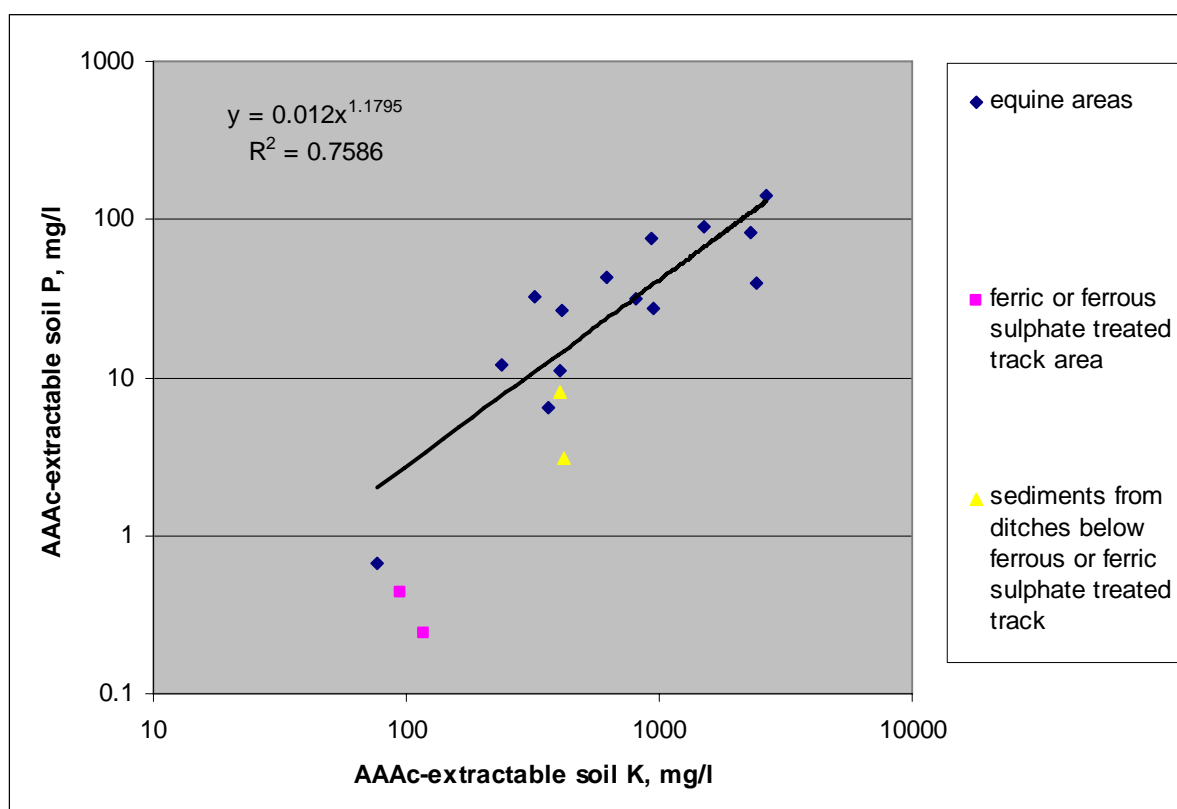
Fig. 9. The Regression of AAAc extractable potassium (mg/l soil) on AAAc-extractable phosphorus in different equine areas. The ferrous or ferric treated soils and the ditch sediment samples are not included in the equation.

As can be seen in Fig. 7 there is a close relationship between the soil extractable potassium and phosphorus. In the Kuuma oval track area the sampled surface soils treated with ferrous or ferric sulphate as well as the ditch sediments from ditches below the treated track area are in a low position in Fig. 9 i.e. it seems that the chemicals reduce the AAAc-extractable phosphorus. The ditch sediment AAAc extractable phosphorus contents are very low compared to the contents in ditch sediment s from equine areas reported by Jansson et al. (2000). As the sediment phosphorus contents are in good correlation with the phosphorus in the water flowing in the ditch this means that we have low phosphorus load ditches beside the tracks (Jansson et al., 2000).
